EAST ELEVATION

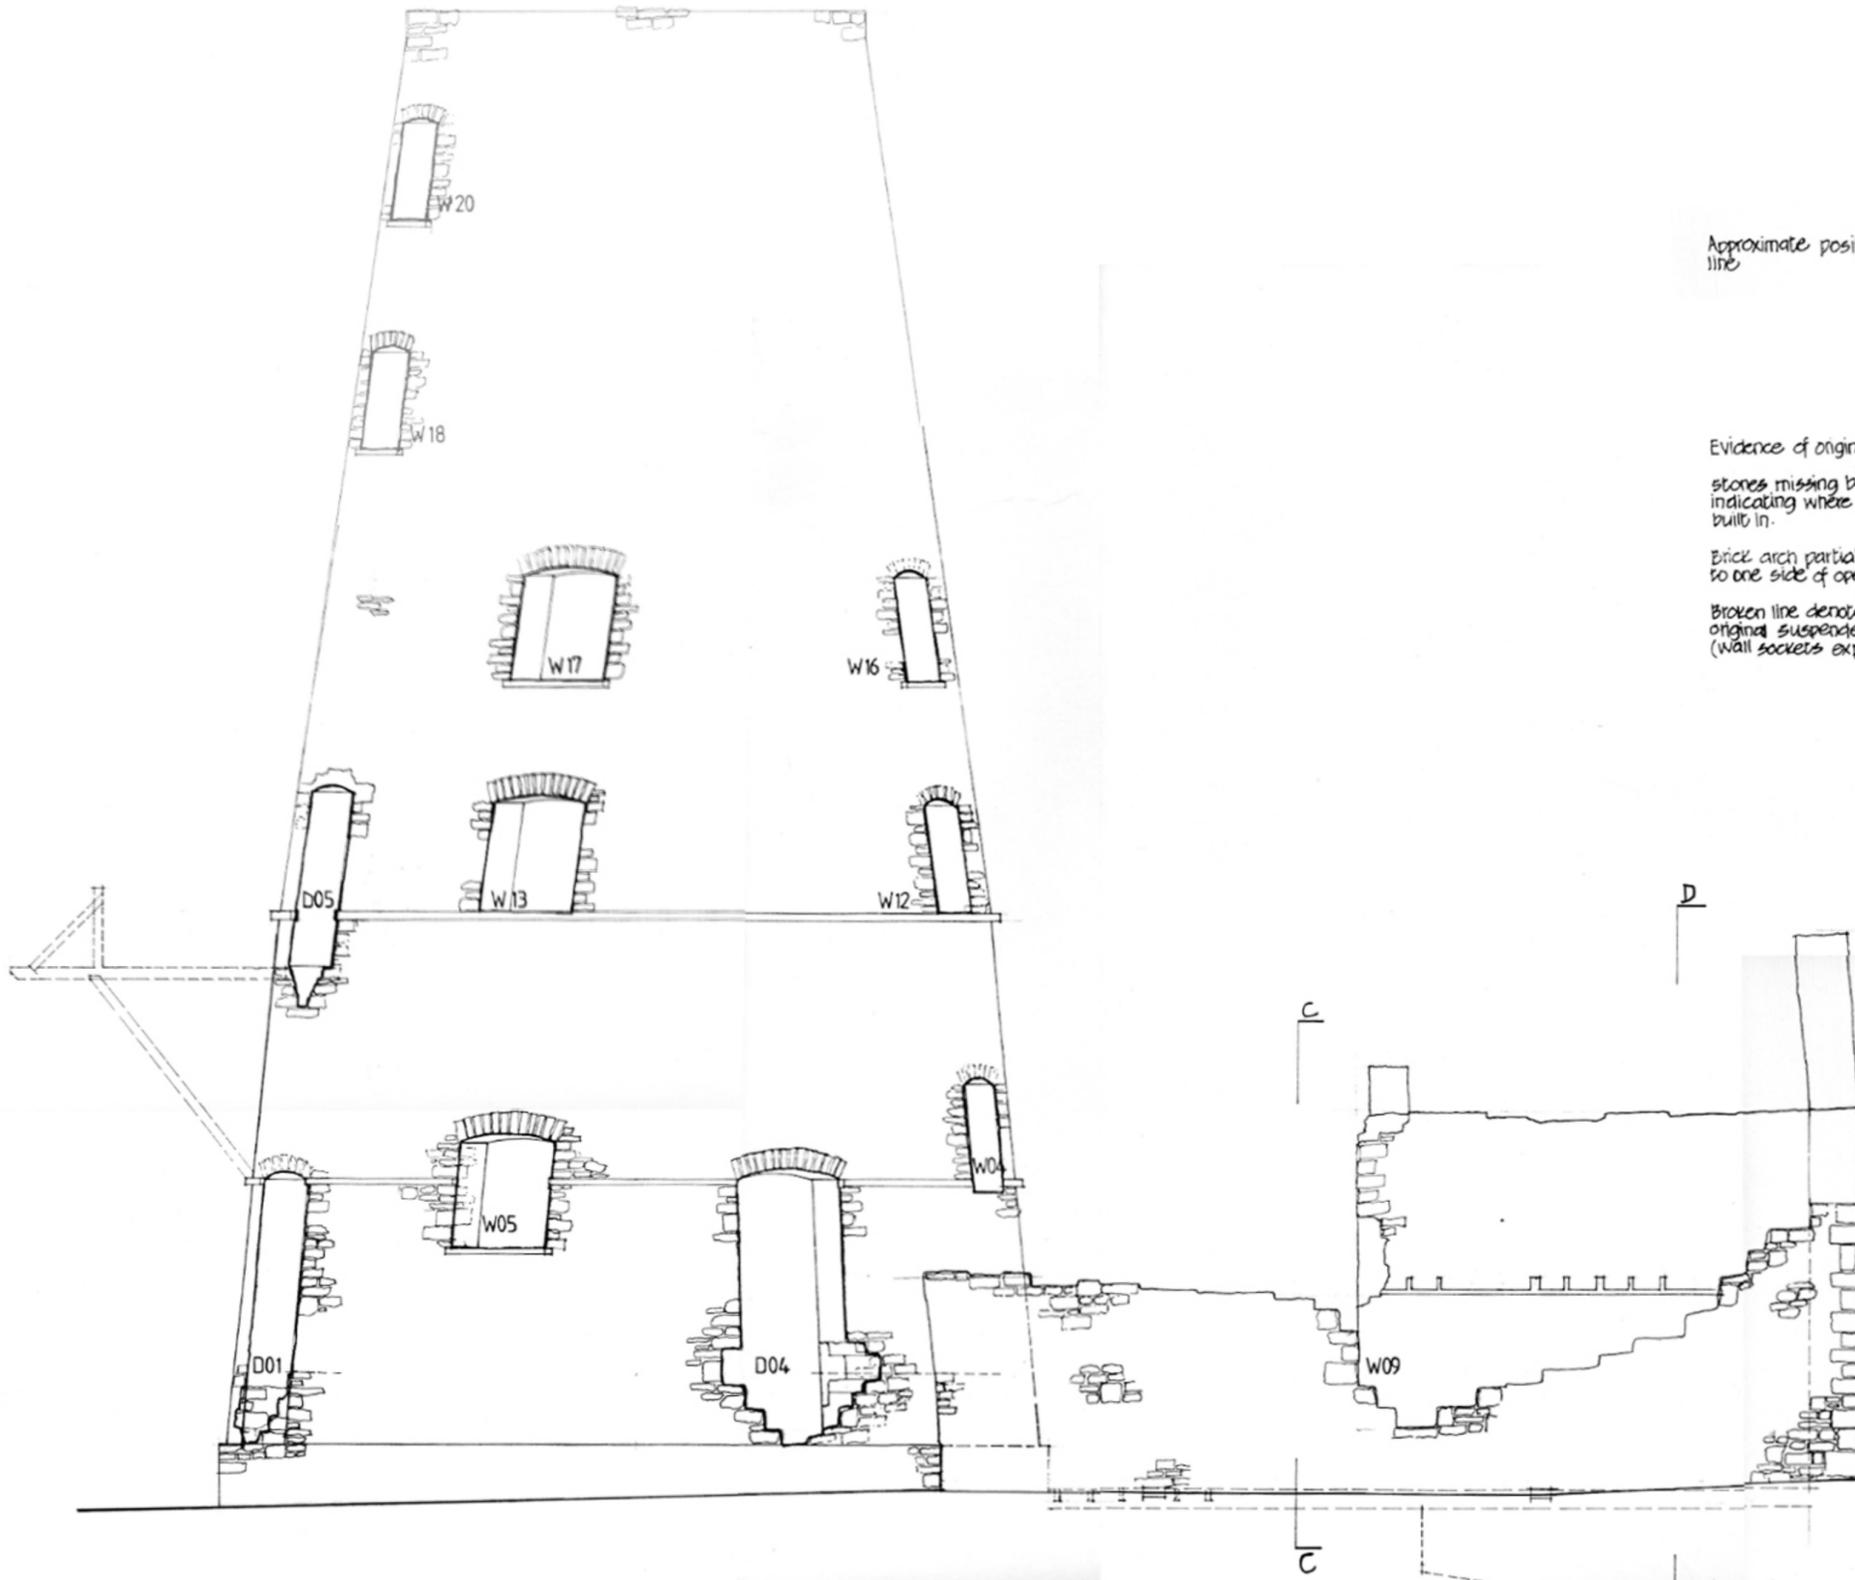
Approximate position of original roof line

Evidence of original lime render

stones missing between broken lines indicating where original wall was built in.

Brick arch partially collapsed to one side of opening.

Broken line denotes position of original suspended timber floor (wall sockets exposed).
